UNITED STATES ENVIRONMENTAL PROTECTION AGENCY
REGION 5
77 WEST JACKSON BOULEVARD
CHICAGO, IL 60604-3590

Re: Notice of Violation
Compliance Evaluation Inspection
EPA I.D. No.: ILD089637847

On May 19, 2015 a representative of the U.S. Environmental Protection Agency inspected the StandardAero Business Aviation facility located in Springfield, Illinois (StandardAero). As a large quantity generator of hazardous waste, StandardAero is subject to the Resource Conservation and Recovery Act, 42 U.S.C. § 6901 *et seq.* (RCRA). The purpose of the inspection was to evaluate StandardAero's compliance with certain provisions of RCRA and its implementing regulations related to the generation, treatment and storage of hazardous waste. A copy of the inspection report is enclosed for your reference.

Attachment A: Photographs for StandardAero Business Aviation (ILD089637847), Springfield, Illinois

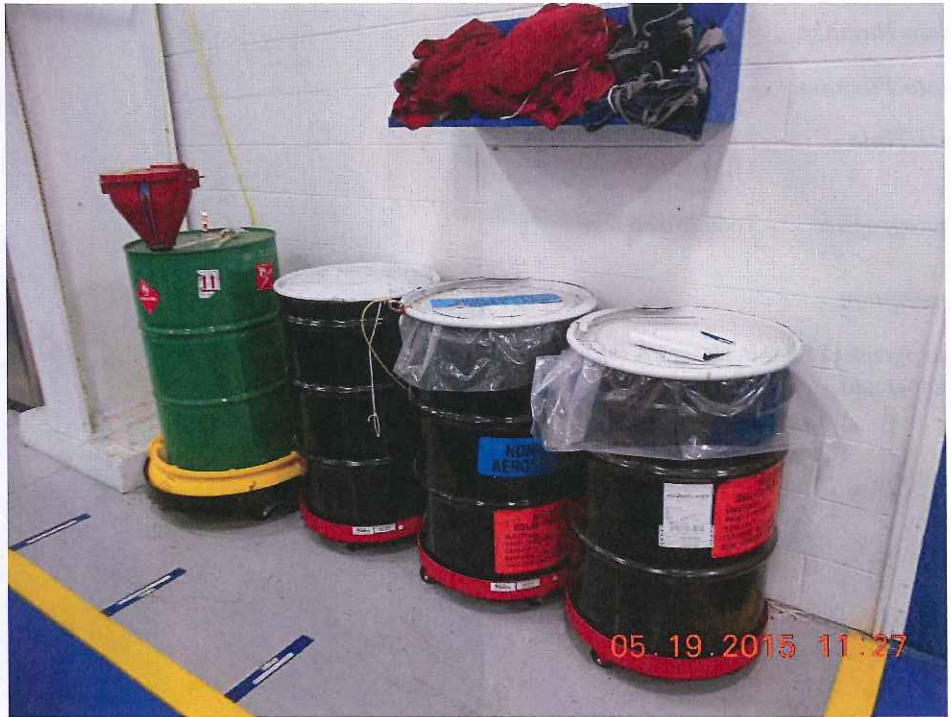
Hangars A through D were each equipped with three to four satellite accumulation containers (photographs 1 and 4) for collection of hazardous solid paint waste, liquid paint waste, aerosol can waste, and humbug detector kit waste (used on testing engine fuel). Each container was labeled as hazardous waste and closed. Used oil collection totes were located in Hangars A and D (photographs 2 and 5). A container of used oil filters, labeled as hazardous waste, was located in Hangar A.

Three hazardous waste satellite accumulation containers and one container of mats located in Hangar A. The satellite containers hold: (1) liquid paint waste, (2) solid paint waste, and (3) aerosol can waste.

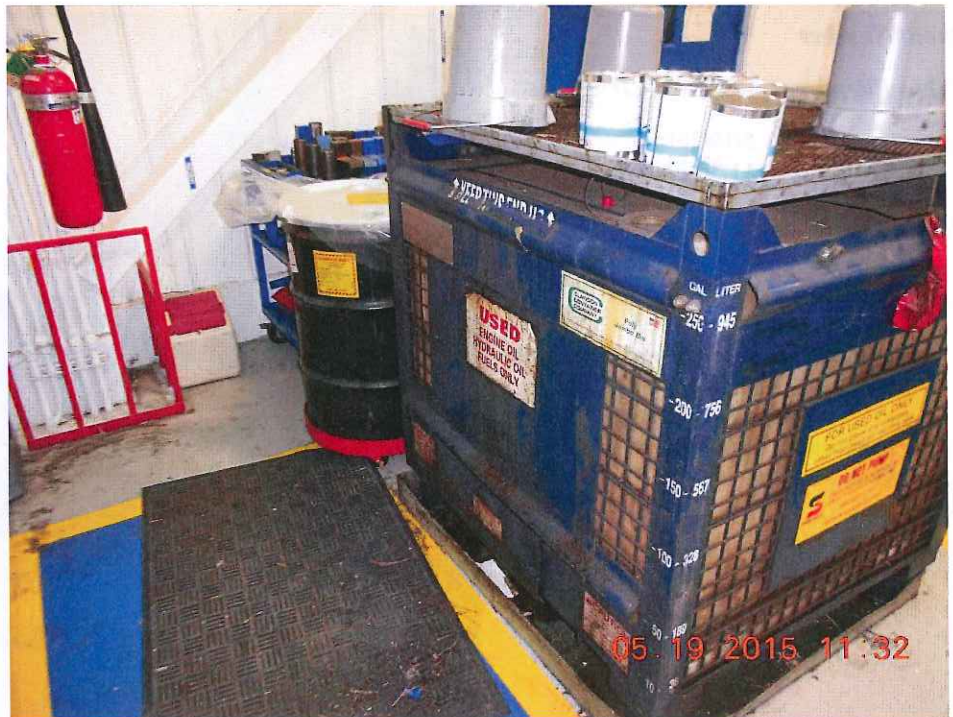
Photo Number 2

Used oil collection tote located in Hangar A.

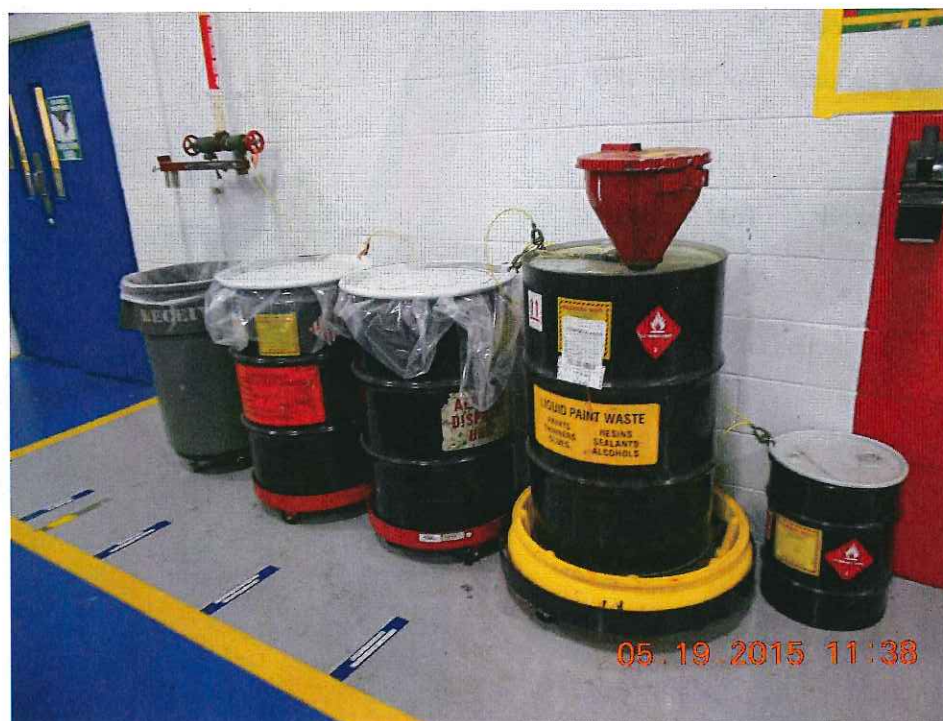
Photo Number 4
Photo Filename DSCN0718.JPG
Date/Time 5/19/2015
11:38:30 AM
Photographer Todd Brown

Four hazardous waste satellite accumulation containers and one trash can located in Hangar C. The satellite containers hold: (1) liquid paint waste, (2) solid paint waste, (3) aerosol can waste, and (4) humbug detector kit waste.

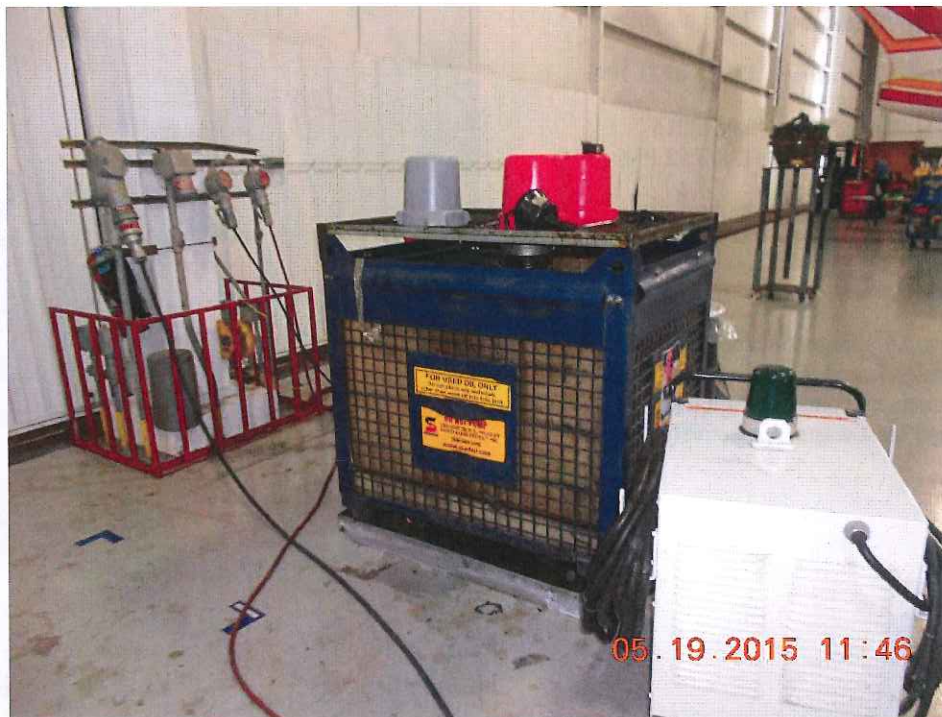
Photo Number 5
Photo Filename DSCN0719.JPG
Date/Time 5/19/2015
11:46:36 AM
Photographer Todd Brown

Used oil collection tote located in Hangar D.

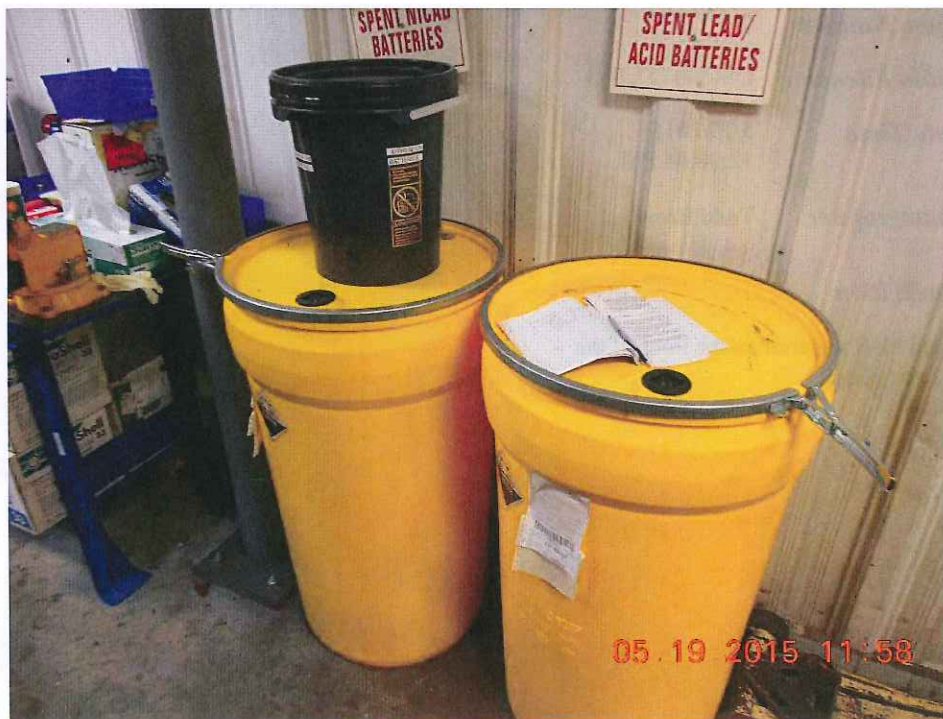
Photo Number 6
Photo Filename DSCN0720.JPG
Date/Time 5/19/2015
11:58:38 AM
Photographer Todd Brown

Three containers of universal waste batteries located in Hangar D. The containers held nickel-cadmium, lithium ion, and lead-acid batteries.

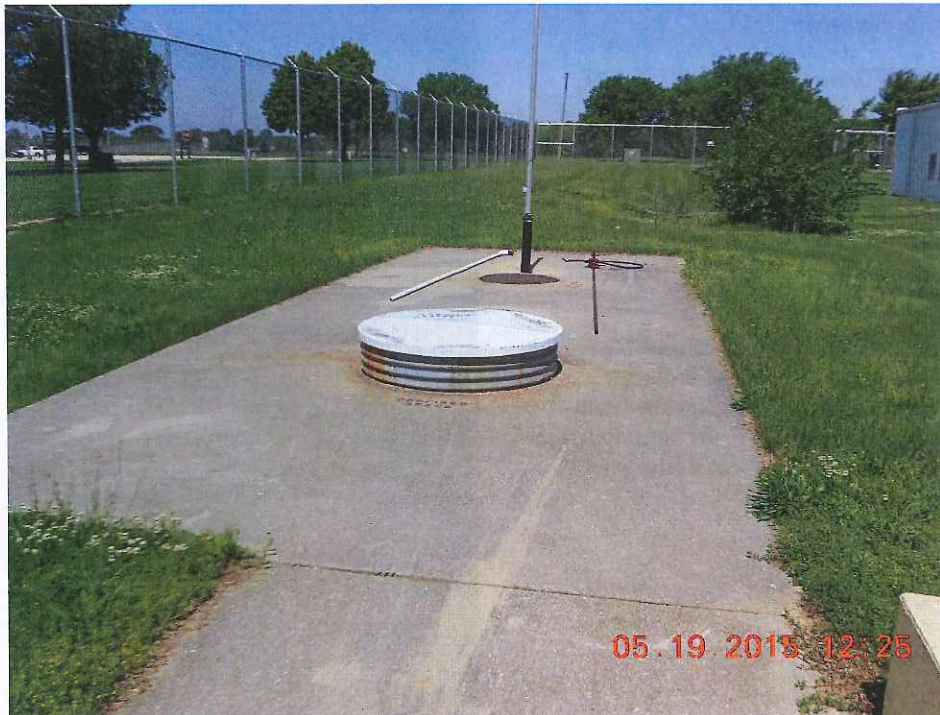
Photo Number 9

Location of an underground storage tank for storage of gasoline removed from aircraft during maintenance.

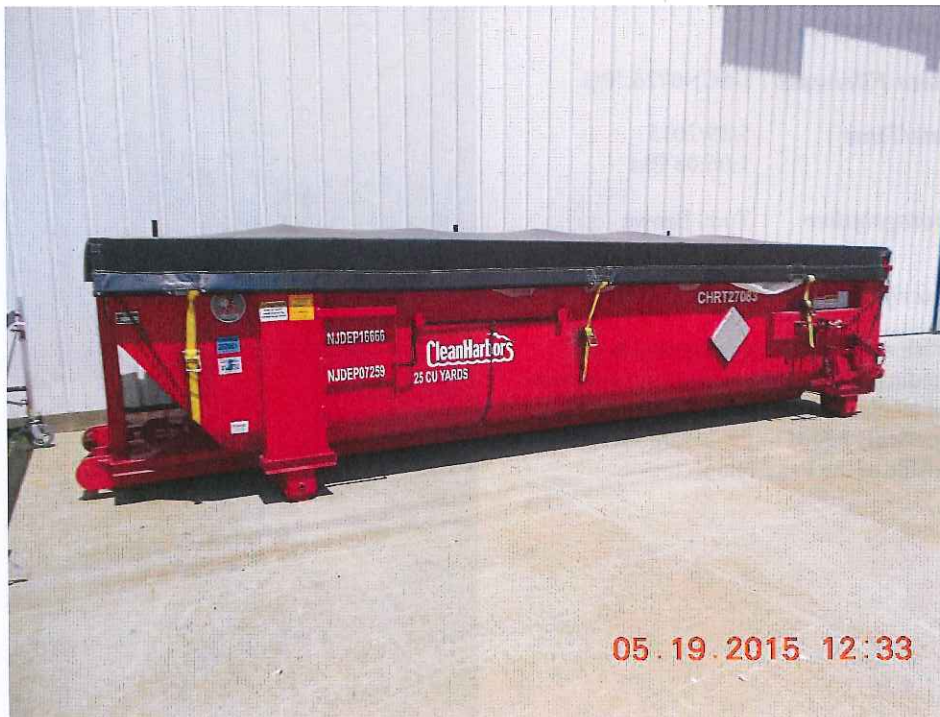
Photo Number 10

A roll-off container for storage of hazardous waste is located outside of the Aircraft Painting Hangar (photograph 10). The container was labeled as hazardous waste, and marked with an accumulation start date of May 17, 2015. According to the facility representatives, it contained paint-booth filters.

Roll-off container of hazardous waste located outside of paint shop. The container holds waste air filters.

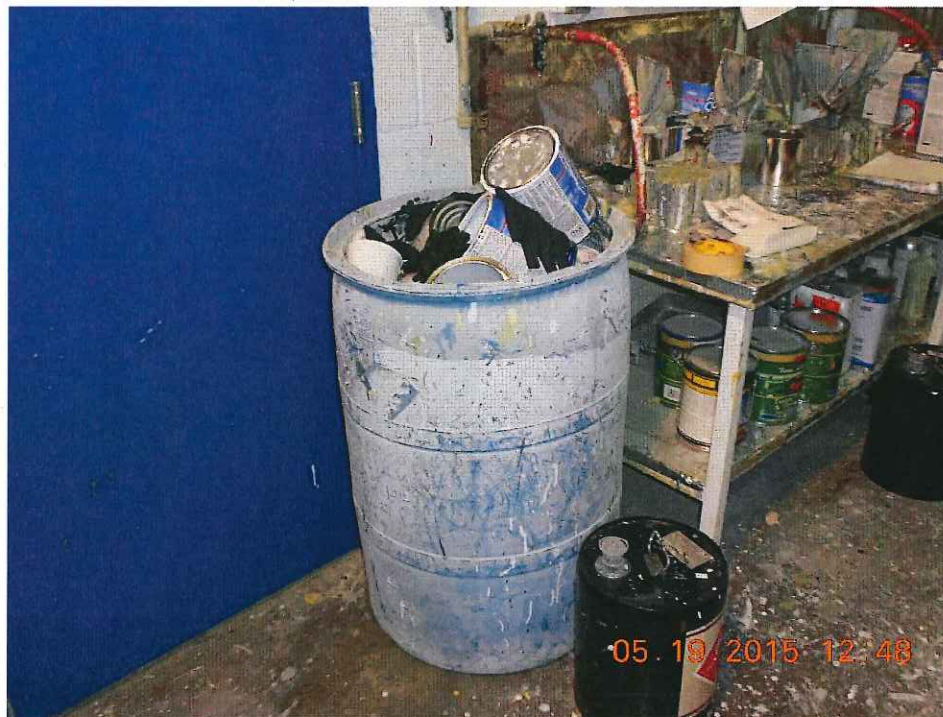
Photo Number 11
Photo Filename DSCN0725.JPG
Date/Time 5/19/2015
12:48:00 PM
Photographer Todd Brown

Container of used paint cans located in the Paint Mixing Room. The container was not labeled or closed. The contents would reportedly be placed in the hazardous waste roll-off container outside of the paint shop.

At the time of the inspection, one container of hazardous paint can waste located in the paint mixing room at the Aircraft Painting Hangar was not labeled with the words, “Hazardous Waste,” or with other content-describing words (see photograph 11 of the attached inspection report).

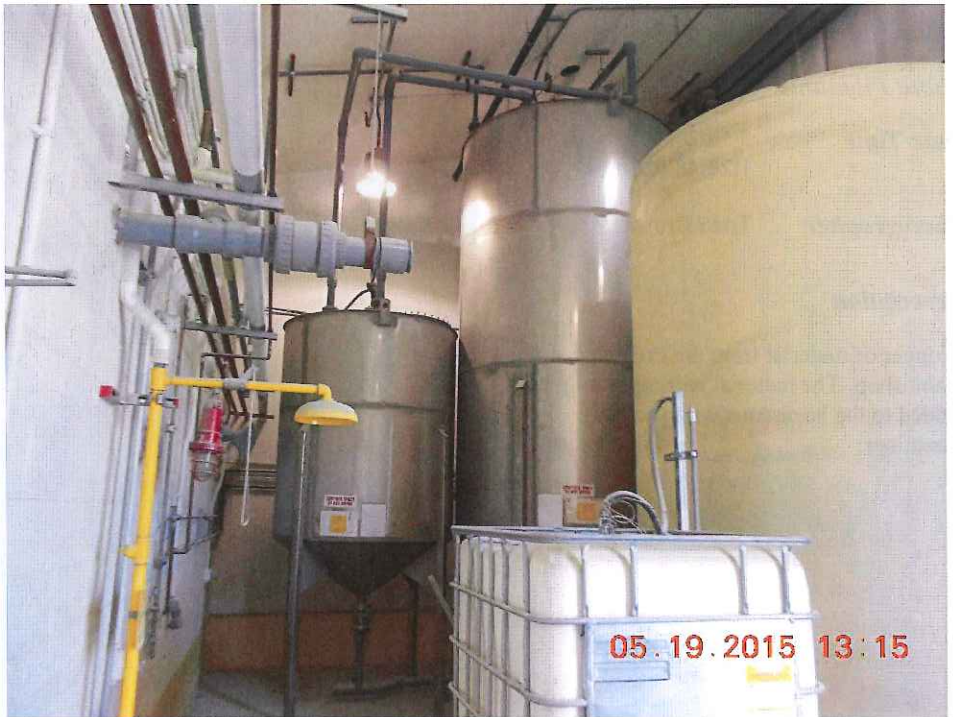
Photo Number 13
Photo Filename DSCN0727.JPG
Date/Time 5/19/2015
1:15:08 PM
Photographer Todd Brown

The two hazardous waste storage tanks are located in the Aircraft Painting Hangar (photograph 13). Both tanks were labeled with the words, "hazardous waste." Reportedly, only the larger tank contained waste at the time of the inspection. The accumulation start date for this tank was noted

as April 15, 2015. The label on the tanks included the words, "Hazardous Waste Liquid," and the EPA hazardous waste numbers: D006, F002, and F019.

Two tanks of hazardous waste located in the Paint Shop (two silver tanks in background of photograph). The tanks are used to accumulate paint stripper waste from stripping paint off of aircraft.

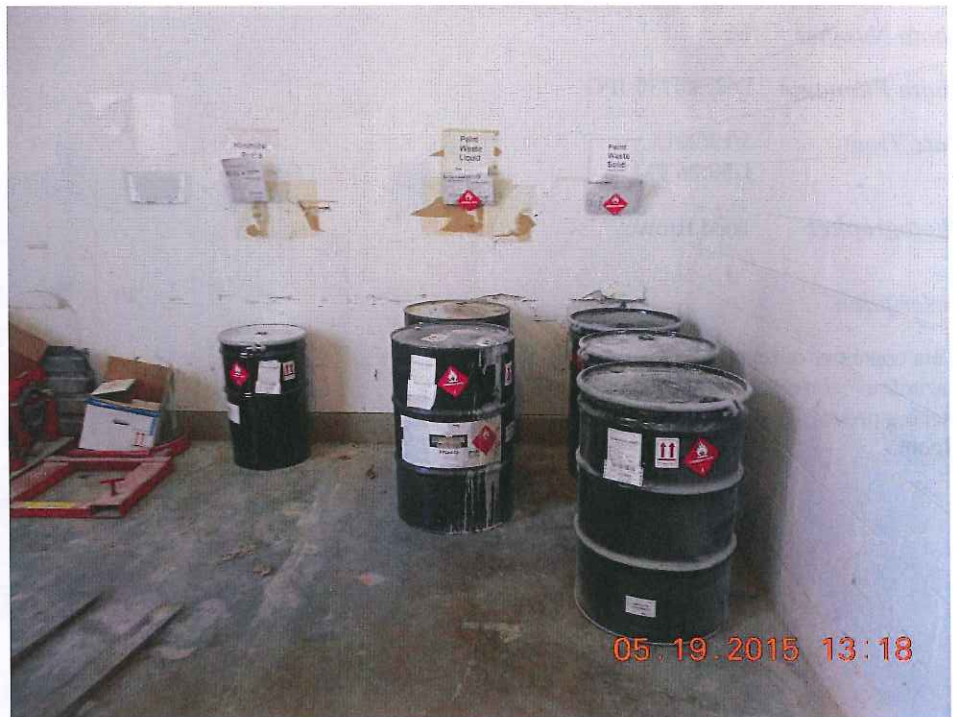
Photo Number 14
Photo Filename DSCN0728.JPG
Date/Time 5/19/2015
1:18:30 PM
Photographer Todd Brown

A "90-day" storage area for containers of hazardous waste is located directly across from the storage tanks. Six containers of hazardous waste were present at the time of the inspection (photograph 14). All of the containers were closed, labeled, and marked with accumulation dates within 90 days of the date of the inspection.

Six containers of hazardous waste located in the 90-day storage area.

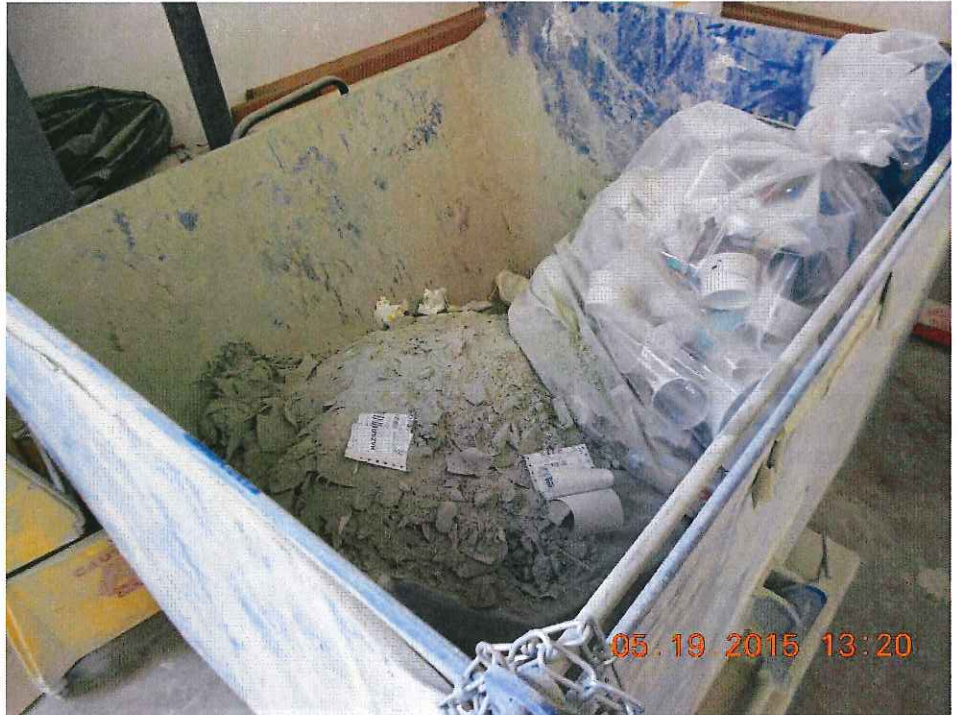
Photo Number 15
Photo Filename DSCN0729.JPG
Date/Time 5/19/2015
1:20:48 PM
Photographer Todd Brown

An open hopper of waste material generated in Hangar P2 was located near the 90 day storage area. The container was not labeled as hazardous waste. However, the StandardAero representatives explained the material would be added to the hazardous waste roll-off container.

Hopper of material from the Prep Bay at the paint shop. The material will reportedly be added to the hazardous waste roll-off container.

At the time of the inspection, a hopper of hazardous waste located in the “90-day” storage area of the Aircraft Painting Hangar was not marked with an accumulation start date (see photograph 15 of the attached inspection report).

At the time of the inspection, a hopper of hazardous waste located in the “90-day” storage area of the Aircraft Painting Hangar was not labeled with the words, “Hazardous Waste” (see photograph 15 of the attached inspection report).

- a) One hopper of hazardous waste located in the “90-day” storage area (see photograph 15 of the attached inspection report);
- b) One container of hazardous waste paint cans located in the paint mixing room (see photograph 11 of the attached inspection report); and
- c) One container of hazardous waste sand paper located in the hangar P2 (see photograph 12 of the attached inspection report).

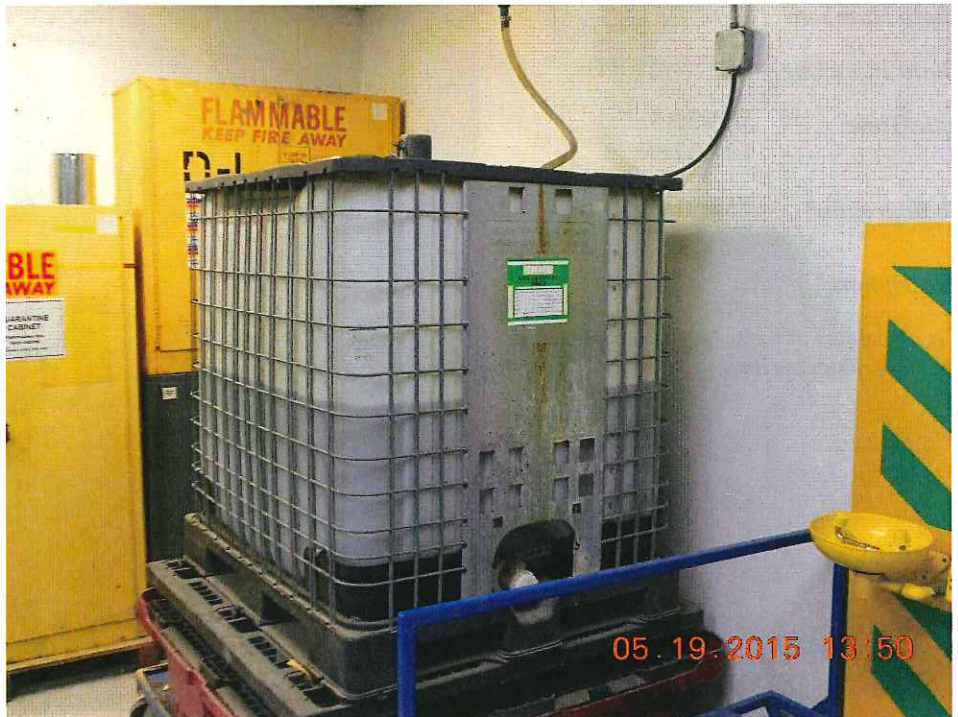
Photo Number 16
Photo Filename DSCN0730.JPG
Date/Time 5/19/2015
1:50:26 PM
Photographer Todd Brown

A room housing a small-scale etching process is located in the Main Hangar. A tote container of rinse water generated by this process was located in the area (photograph 16). The container was labeled as a "non-hazardous" waste.

Tote container of reportedly "non-hazardous" rinse waste from a small-scale etching process located in the Etch Alodine Room.
